# Farmington Meadows

## Level 2 Reserve Study

| <b>Type of Study</b> | <b>Update w / Site Visit</b> |
| <b>Date of Property Inspection</b> | <b>6/7/2017</b> |

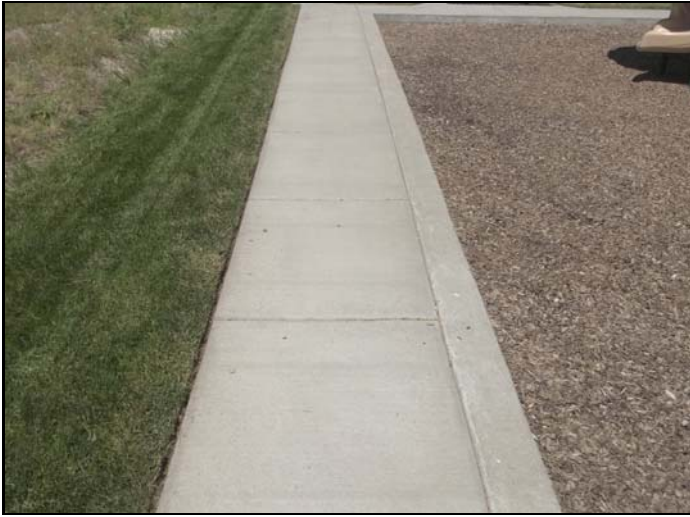
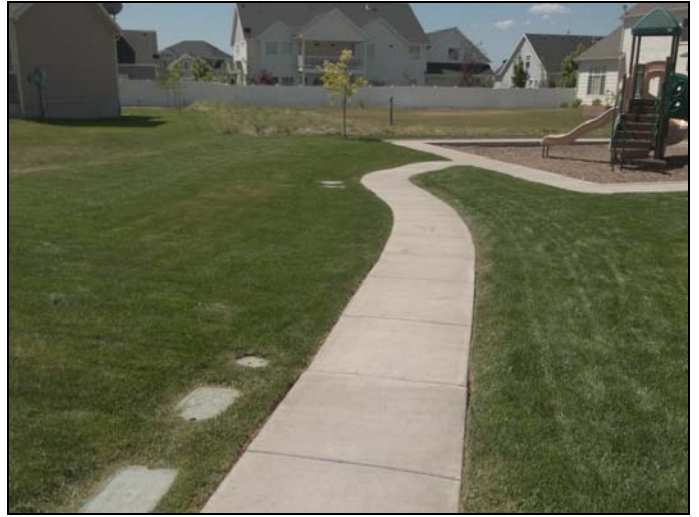
Comp #: 403 Concrete - Repair/Replace

*Location:* **Park Area Sidewalks**

The concrete is in good condition. Due to the minimal amount of this component, reserve funding is not appropriate. Repair and replace as necessary as an operating expense. No reserve funding necessary.

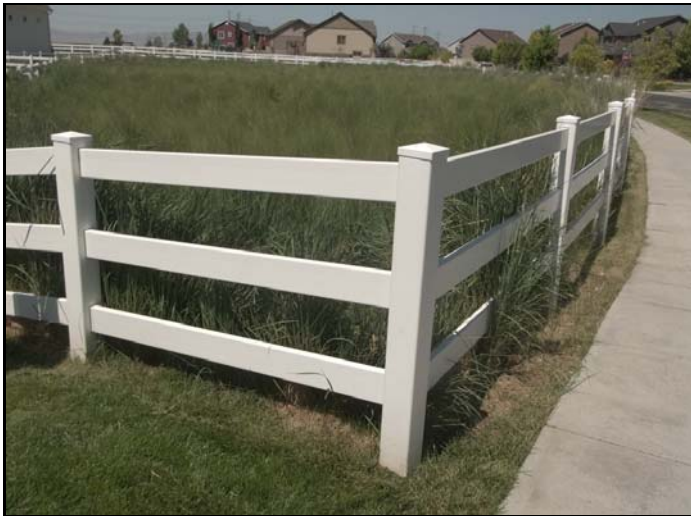
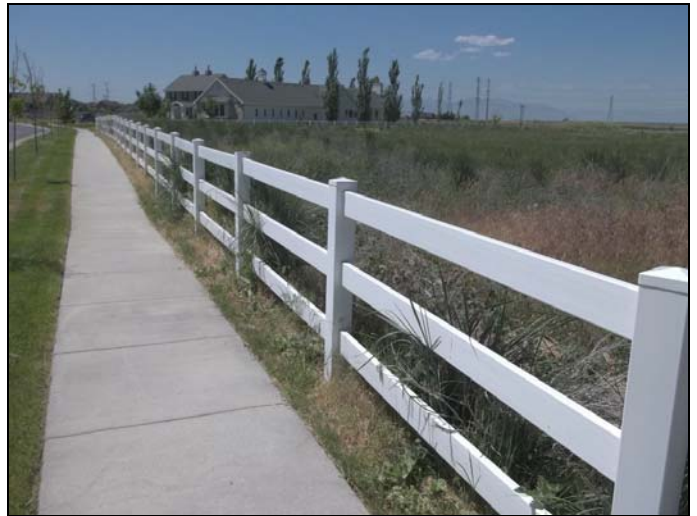
Comp #: 1008 Vinyl Fencing - Replace

*Location:* **Wetlands Perimeter**

The vinyl fencing is in good condition. We recommend funding to replace this component approximately every 25 - 30 years. Remaining life based on current age.

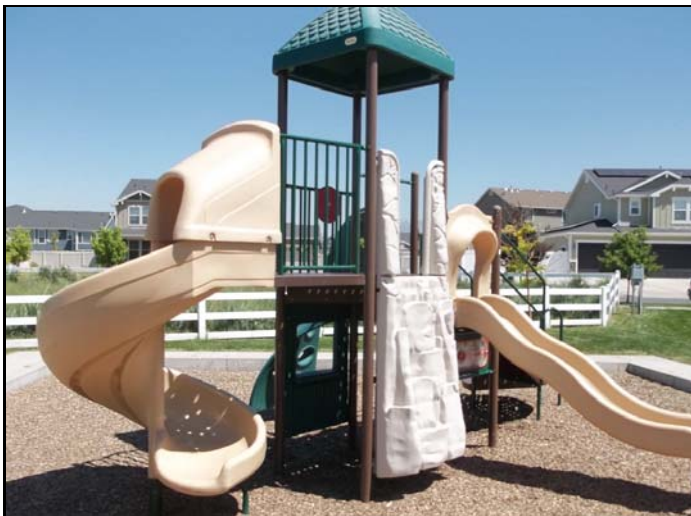
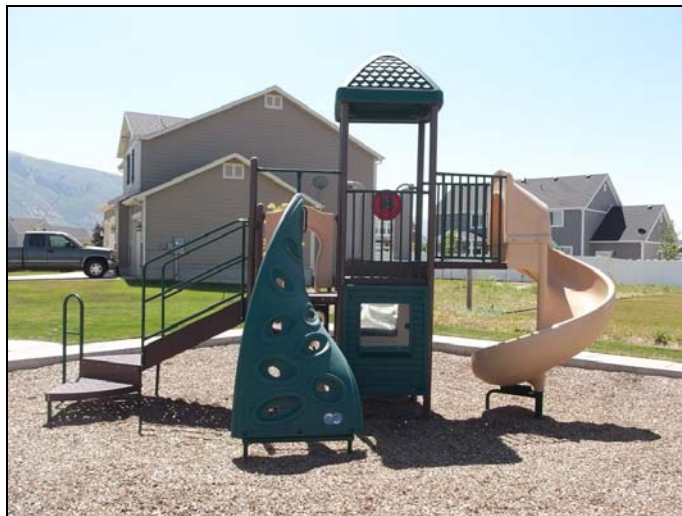
Comp #: 1301 Play Structure - Replace

Location: **Park Area**

The play structure is in good condition. We recommend funding to replace this component approximately every 20 - 25 years. Remaining life based on current age.

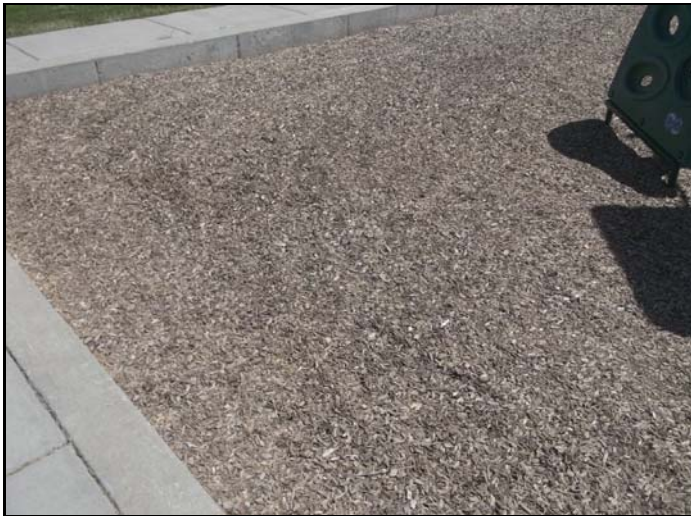
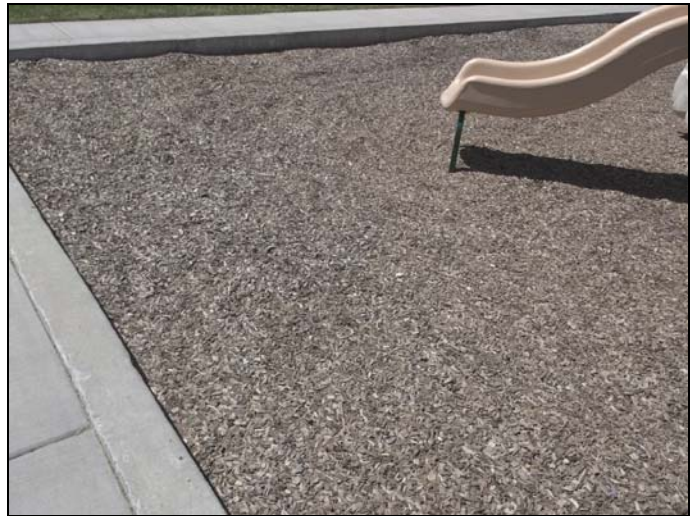
Comp #: 1303 Play Area Groundcover - Refill

*Location:* **Play Area**

The play area groundcover is in good condition. We recommend funding to refill this component approximately every 3 - 5 years to maintain appearance and ensure proper function as a safety component. Remaining life is based on current condition.

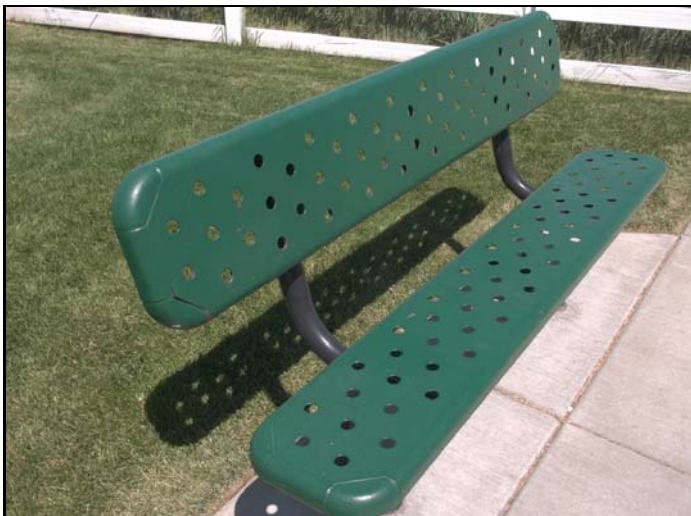
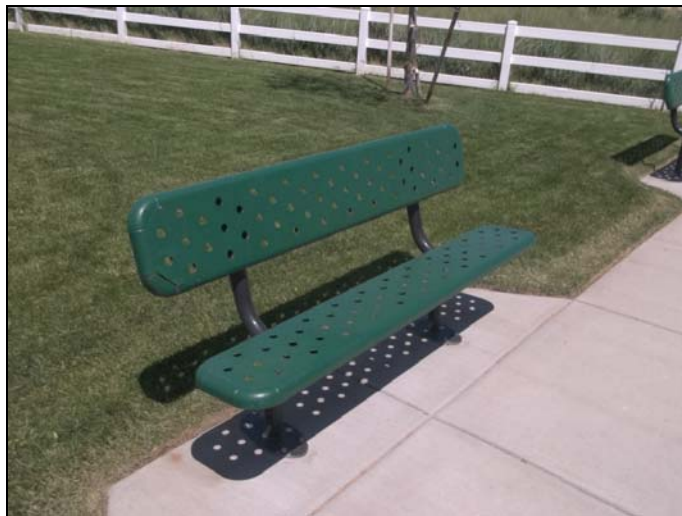
Comp #: 1307 Benches - Replace

*Location:* **Park Area**

The benches are in fair condition. Plastic coating peeling off was noted at the time of the inspection. We recommend funding to replace this component approximately every 10 - 15 years. Remaining life based on current age.

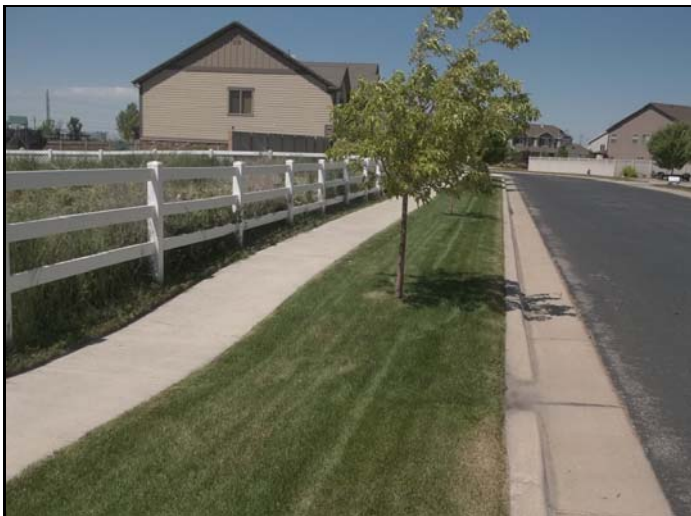
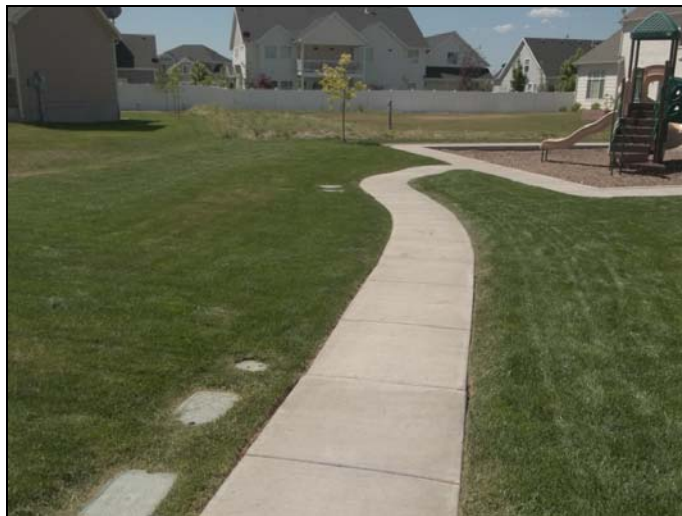
Comp #: 1812 Landscaping - Renovate

*Location:* **Park Area & Park Strips by Wetlands**

The landscaping and irrigation system are in good condition. We recommend funding for an allowance to renovate the landscaping and irrigation system approximately every 20 years. Remaining life based on current age.
